# Inspection requirement

## Check O-ring defect

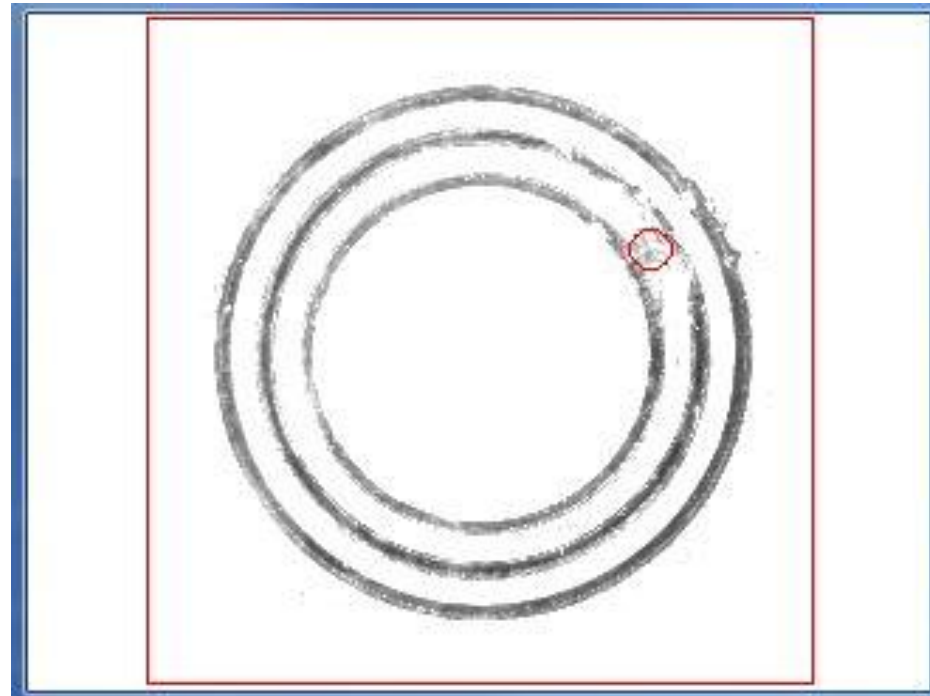
# Defect on the ID ring

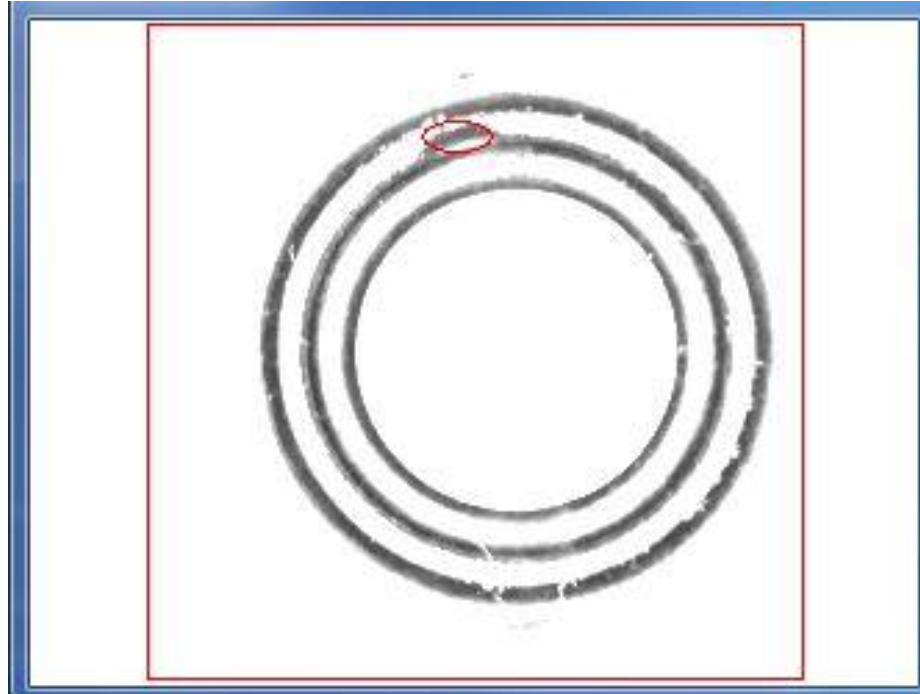
# Defect on the MD ring

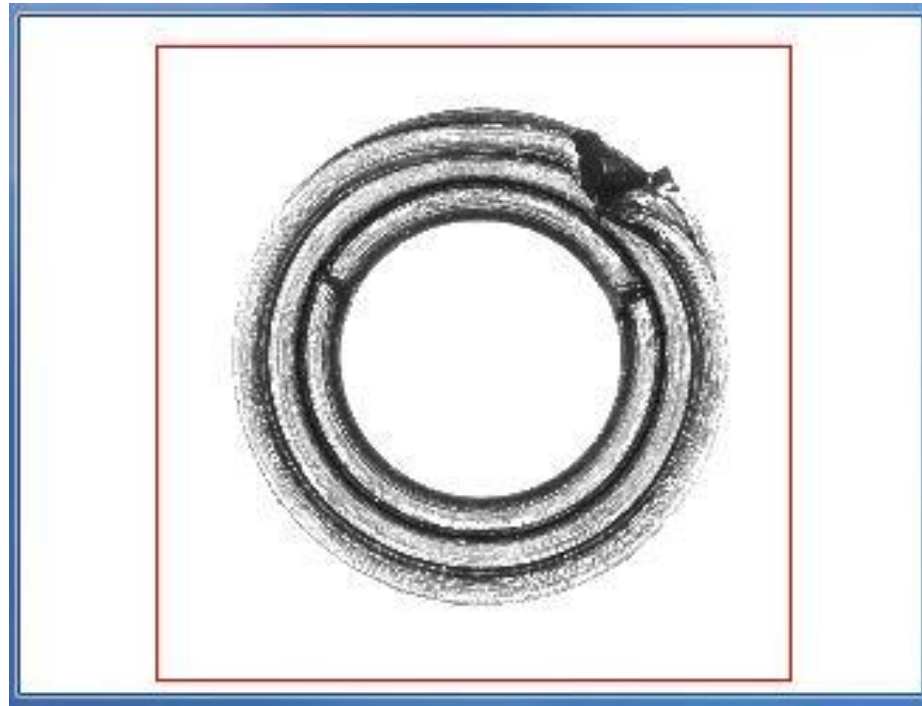
# Defect on the OD ring

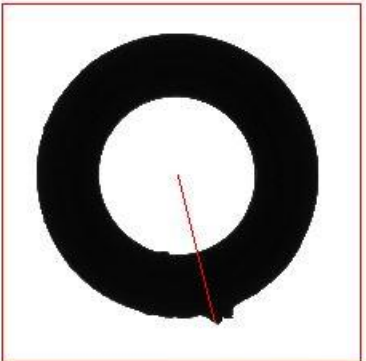
# Burr

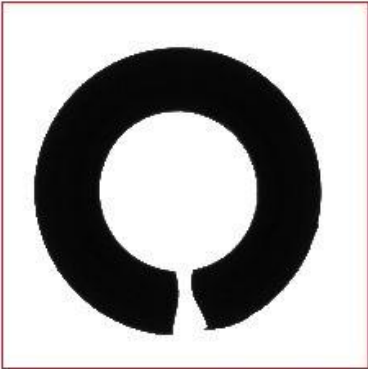
# Crack through / Crack

Characteristic	Reject count	USL value	LSL value	Inspect value U	Inspect value L
Dim. H01 (C1)	0	1.000	0.000	0.0000	0.0000
Defect VP01 (C2)%	0	1.000	0.000	0.0000	0.0000
Dim. D01 (C5)	0	5.100	4.800	4.9723	4.9723
Dim. R01 (C5)	0	2.560	2.450	2.4914	2.4914
Crack Through 01 (C5)	0	1.000	0.000	11111.0000	11111.0000
