# Inspection requirement

## Check O-ring defect

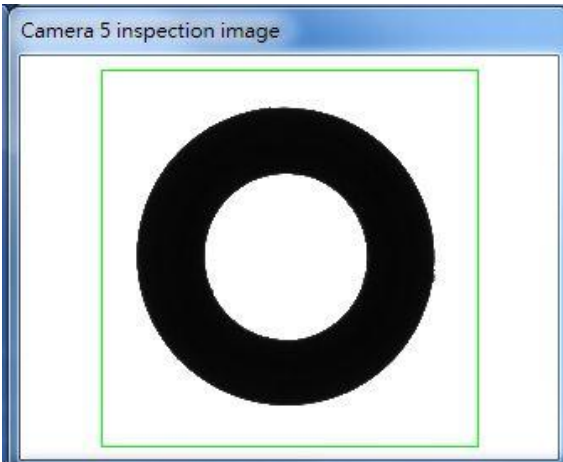
# Burr

Current inspecting status (avInsertG100\_20170323)

Inspected count :	271735	pieces	Inspect speed :	17056.11	ppm
Passed count :	134595	pieces	E recycle count :	3	pieces
Rejected count :	137137	pieces	E fail count :	137137	pieces
Rejected rate :	50.47	%	Span rejected :	0.00	%
Package count :	0	pieces	Package no. set :	1000	pieces
Package lot :	0	10	0	Inspect stop

Inspect value

Characteristic	Reject count	USL value	LSL value	Inspect value U	Inspect value L
Dim. H01 (C1)	0	1.000	0.000	0.0000	0.0000
Defect VP01 (C2)%	0	1.000	0.000	0.0000	0.0000
Dim. D01 (C5)	0	5.100	4.800	5.0159	5.0159
Dim. R01 (C5)	0	2.560	2.450	2.5188	2.5188
Crack Through 01 (C5)	0	1.000	0.000	0.0000	0.0000

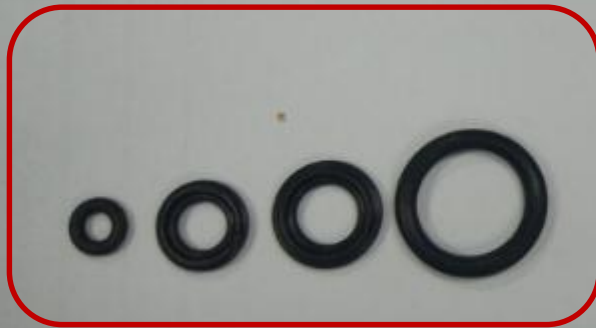
Part 1

# New sample for Feeding bowel
